**Flood Control Project Maintenance
Levee Inspections**

Maintenance Issue Types Only, Levee Inspection Report By Mile - Spring 2017

Butte County Department of Public Works

Waterway	Bank	Unit Miles	Inspection Start/End	Inspector
Unit No. 01 Mud Creek	Right	6.80	04/20/2017 04/20/2017	Bob Duffey

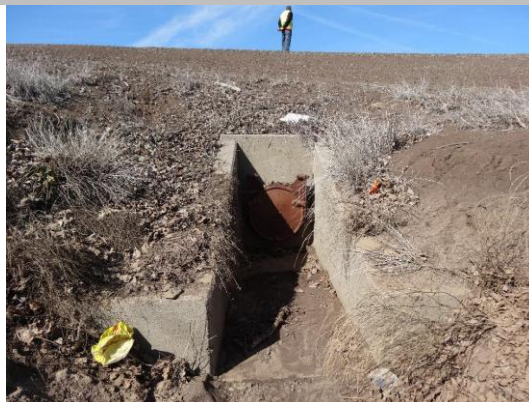
Photo 1 of 3 : UCIP_SP_2017_29705_54924.jpg

WS view: U typed concrete headwall, flapgate on levee slope.

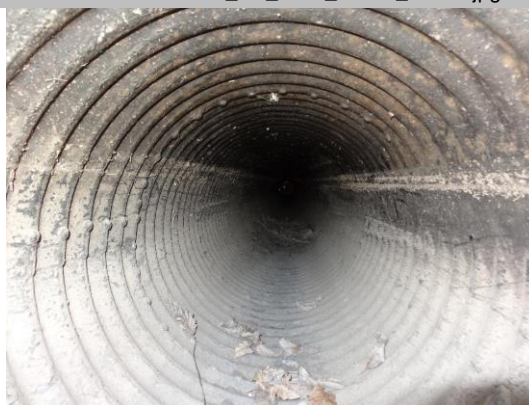
Photo 3 of 3 : UCIP_SP_2017_29705_54922.jpg

LS view: inside view of CMP on levee slope. Looks clean and clear.

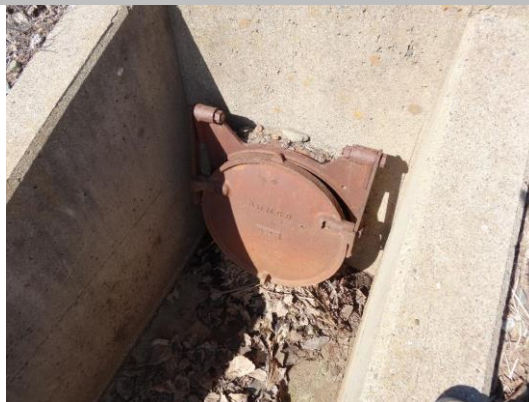
Photo 2 of 3 : UCIP_SP_2017_32044_58542.jpg

WS view: vegetation debris blocking outlet.

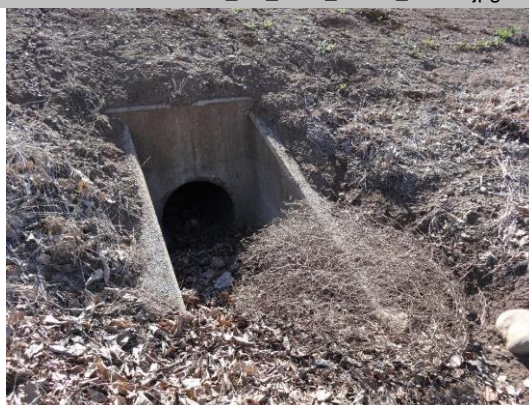
Photo 2 of 3 : UCIP_SP_2017_50142_55885.jpg

LS view: U type concrete headwall and CMP on levee slope. Vegetation debris blocking inlet.

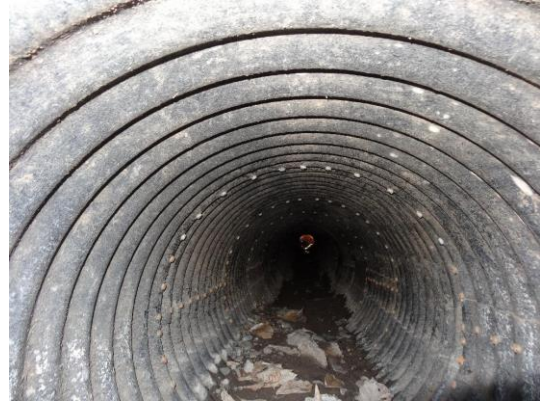
Photo 3 of 3 : UCIP_SP_2017_50142_55884.jpg

LS view: inside view of CMP on levee slope. Needs cleaning and clearing.

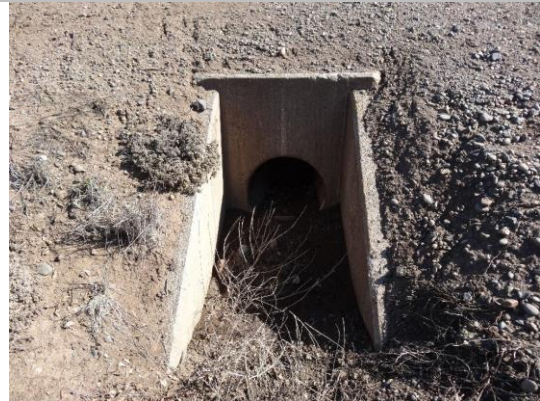
Photo 2 of 2 : UCIP_SP_2017_30294_55703.jpg

FS_ID:30294
DS_ID:19216
EP_NO: N/A
Repair Type: Non-Urgent
Crossing Status: Found
UCIP Comments: Inlet and outlet needs cleaning and clearing of debris.
FIELD_STRUCT_DESC: 24-inch CM pipe through levee, 8.5 feet below the crown. Flap gate on the waterward end. Concrete "U" headwalls on both ends. Grouted riprap apron on the landward end. Grouted riprap spillway on the waterward end. O&M Manual Sac 504, May 1965.
FS Date: 2/20/2014

LS view: U type concrete headwall and CMP on levee slope. Debris blocking the inlet pipe.

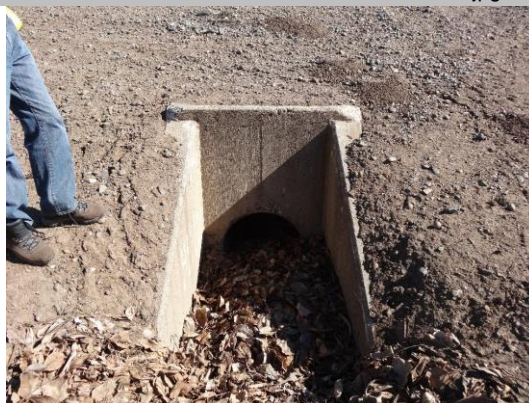
Photo 2 of 2 : UCIP_SP_2017_30295_55705.jpg

LS view: U type concrete headwall and CMP on levee slope. Vegetation debris blocking the inlet.

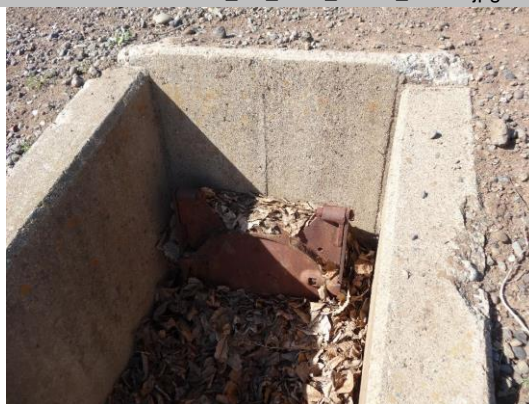
Photo 1 of 3 : UCIP_SP_2017_30310_55741.jpg

WS view: U type concrete headwall, pipe, and flapgate on levee slope. Vegetation debris blocking outlet.

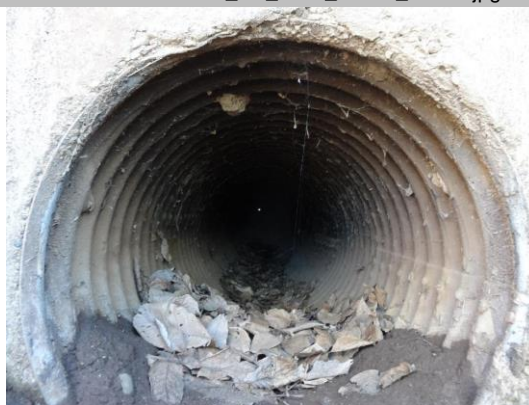
Photo 3 of 3 : UCIP_SP_2017_30310_55739.jpg

LS view: inside view of CMP on levee slope. Needs cleaning and clearing.

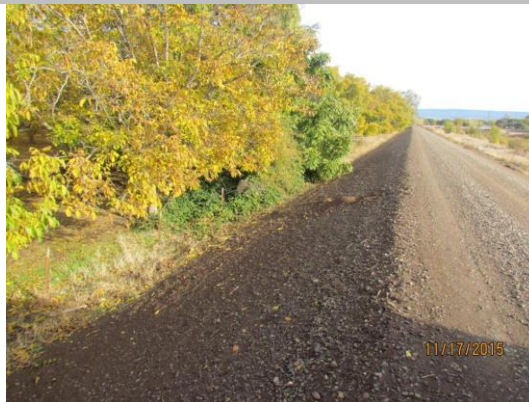
Photo 1 of 1 : SP_2017_NA0003_64_33_20170315_00016.jpg

View of the rodent holes along the landside slope.

LM Start	4.27	Rating **	M	Issue No.	33
LM End	4.27	Issue Type +	Ma	Location *	LS
Category	Earthen Levee			GPS Latitude/Longitude	
				Start	End
Item	Animal Control			39.773398 °	39.773398 °
				-121.895765 °	-121.895765 °
DWR ID	DWR_NA0003_01_f_2015_33				
Comment Code					
A1 : Exterminate rodents and backfill and compact or grout burrows.					
Inspector Comment					
Repair the rodent holes along the landside slope.

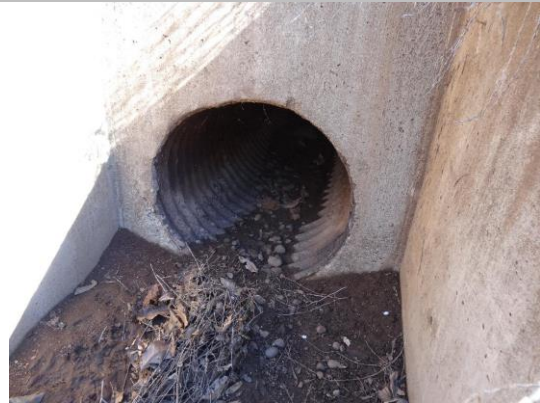
Photo 2 of 2 : UCIP_SP_2017_30312_55744.jpg

LS view: U type concrete headwall and CMP on levee slope. Needs cleaning and clearing of debris.

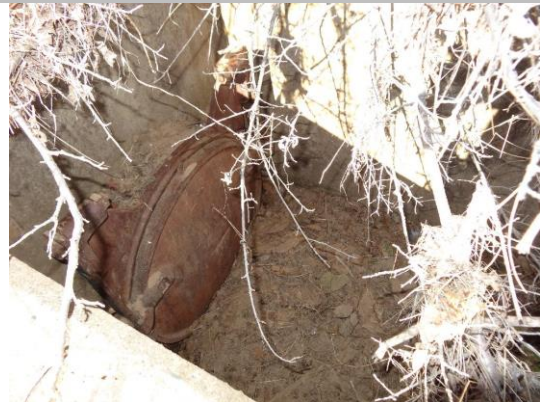
Photo 1 of 2 : UCIP_SP_2017_30388_55891.jpg

WS view: U type concrete headwall, pipe, and flapgate on levee slope. Vegetation/soil debris blocking outlet.

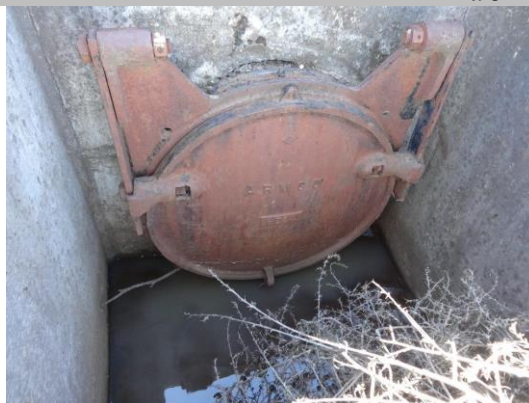
Photo 2 of 3 : UCIP_SP_2017_31667_57967.jpg

WS view: U type concrete headwall, pipe, and flapgate on levee slope. Vegetation debris on outlet box.

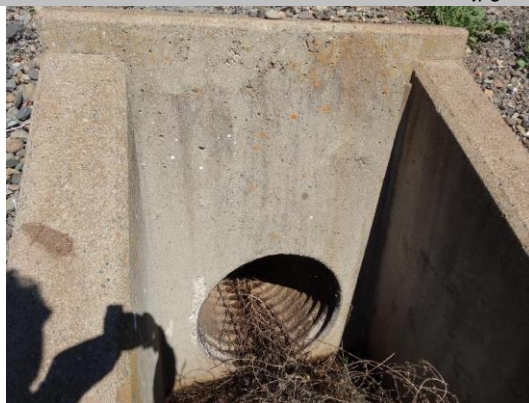
Photo 3 of 3 : UCIP_SP_2017_31667_57966.jpg

LS view: U type concrete headwall and CMP on levee slope. Vegetation debris on inlet box.

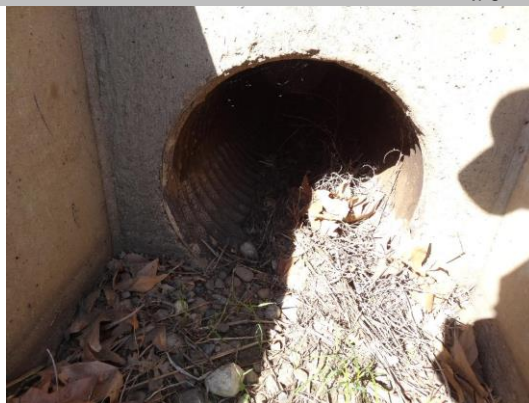
Photo 2 of 3 : UCIP_SP_2017_30403_55921.jpg

LS view: U type concrete headwall and CMP on levee slope. Vegetation debris in inlet pipe.

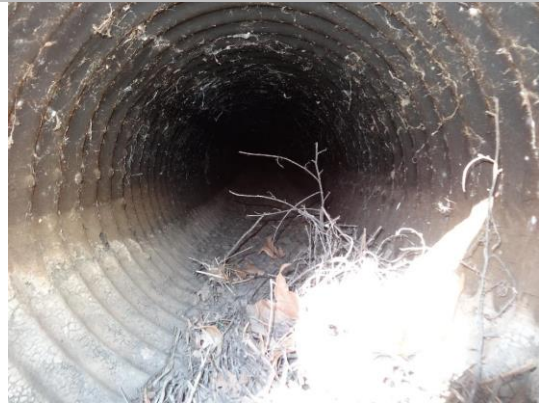
Photo 3 of 3 : UCIP_SP_2017_30403_55920.jpg

LS view: inside view of CMP on levee slope. Needs cleaning and clearing.

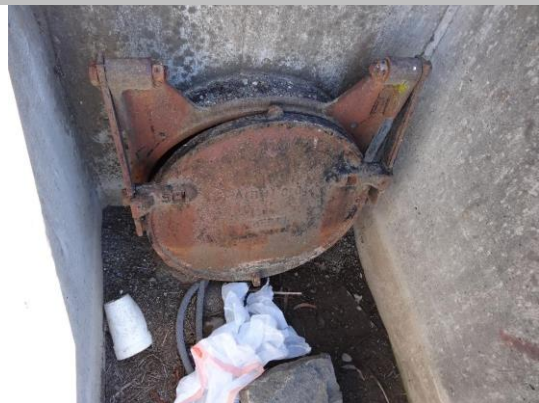
Photo 1 of 2 : UCIP_SP_2017_30743_56641.jpg

WS view: U type concrete headwall, pipe, and flapgate on levee slope. Debris in outlet box.

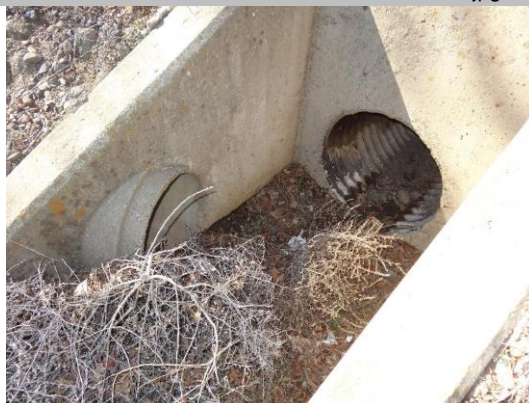
Photo 2 of 2 : UCIP_SP_2017_30743_56640.jpg

LS view: U type concrete headwall and CMP on levee slope. Vegetation debris and soil in inlet area.

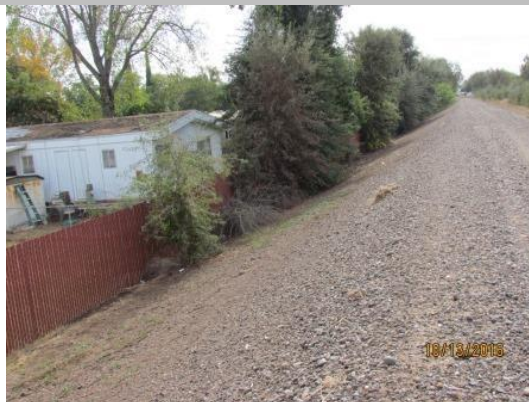
Photo 1 of 1 : SP_2017_NA0003_65_31_20170315_00009.jpg

View of the trees along the landside toe.

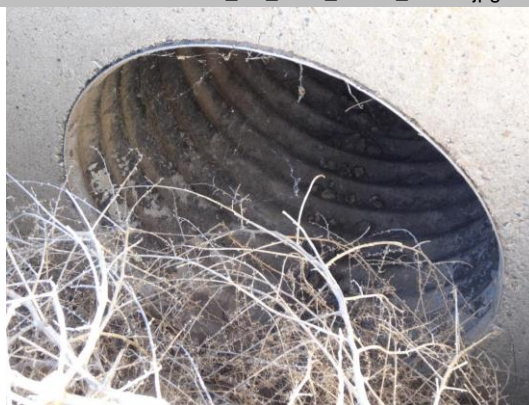
Photo 3 of 3 : UCIP_SP_2017_30803_56683.jpg

LS view: inside view of CMP on levee slope. Needs cleaning and clearing.

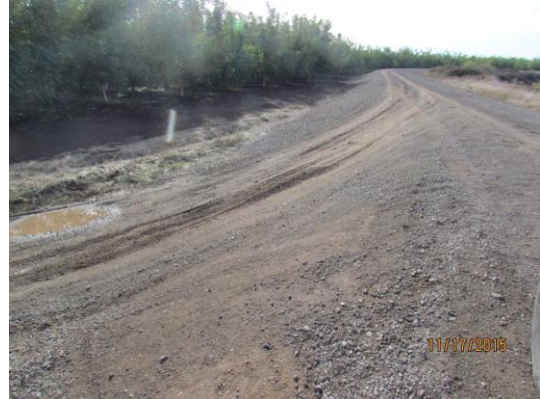
Photo 1 of 1 : SP_2017_NA0003_65_10_20170315_00006.jpg

View of the vehicle erosion along the landside slope.

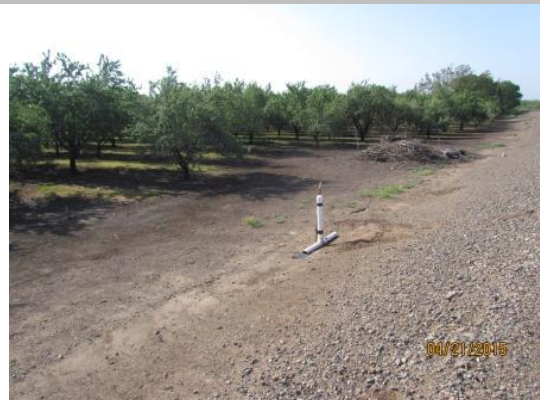
Photo 1 of 2 : SP_2017_NA0003_65_8_20170315_00004.jpg

View of the bait station placed by the rodent hole.

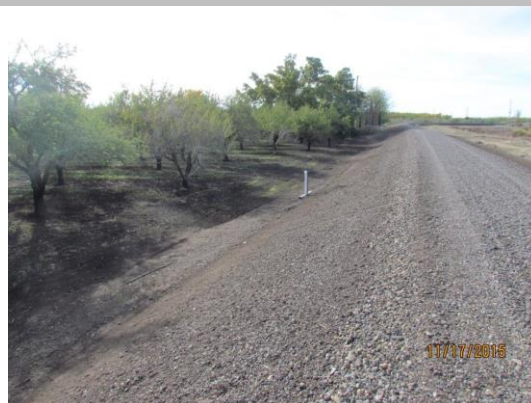
Photo 2 of 2 : SP_2017_NA0003_65_8_20170315_00005.jpg

View of the bait station by the rodent holes.

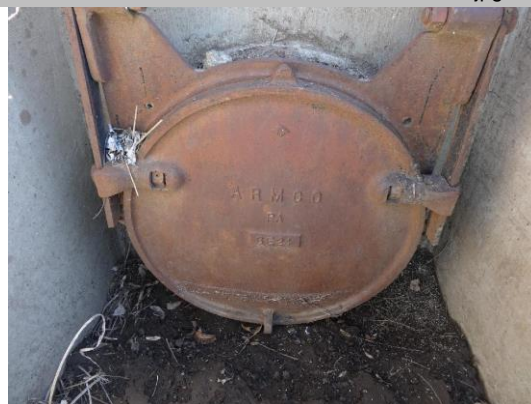
Photo 1 of 3 : UCIP_SP_2017_31028_56913.jpg

WS view: U type concrete headwall, pipe, and flapgate on levee slope.
 Soil/mud on outlet box.

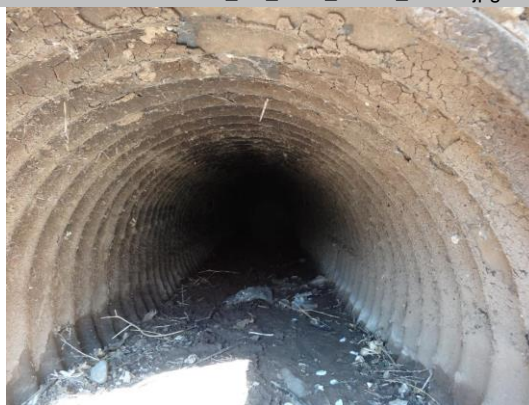
Photo 3 of 3 : UCIP_SP_2017_31031_56915.jpg

LS view: inside view of CMP on levee slope. Needs cleaning and clearing.

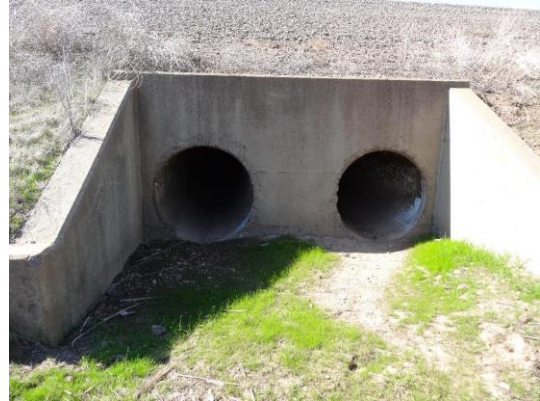
Photo 3 of 3 : UCIP_SP_2017_41377_56921.jpg

LS view: U type concrete headwall and CMPs on levee slope. Soil/mud on inlet box.

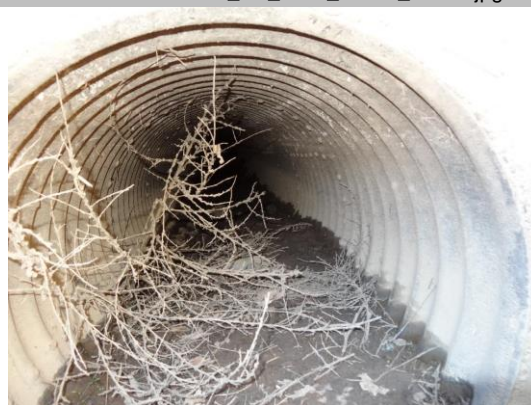
Photo 3 of 3 : UCIP_SP_2017_31103_57000.jpg

LS view: inside view of CMP on levee slope. Needs cleaning and clearing.

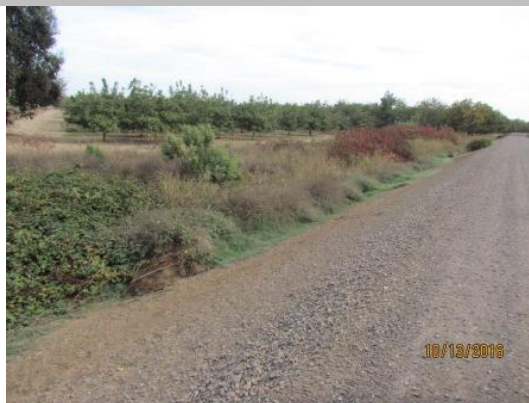
Photo 1 of 1 : SP_2017_NA0003_65_40_20170315_00017.jpg

View of the dense vegetation along the landside toe blocking visibility and access.

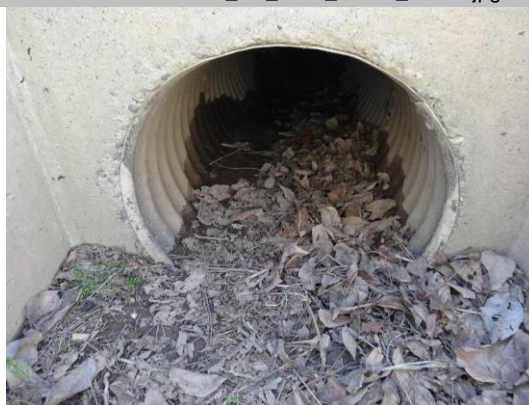
Photo 2 of 2 : UCIP_SP_2017_31129_57035.jpg

LS view: U type concrete headwall and CMP on levee slope. Soil/mud and vegetation on inlet box.

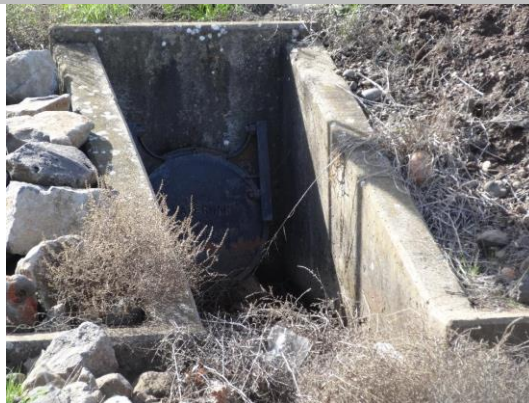
Photo 1 of 3 : UCIP_SP_2017_32124_58625.jpg

WS view: concrete headwall, pipe, and flapgate on levee slope.
Vegetation and mud on outlet box.

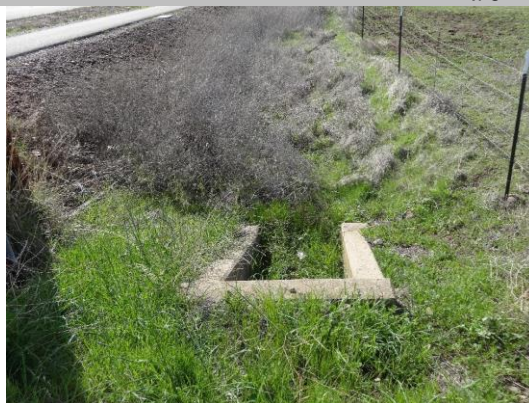
Photo 2 of 3 : UCIP_SP_2017_32124_58624.jpg

LS view: U type concrete headwall of CMP culvert on levee slope.
Vegetation on inlet box.

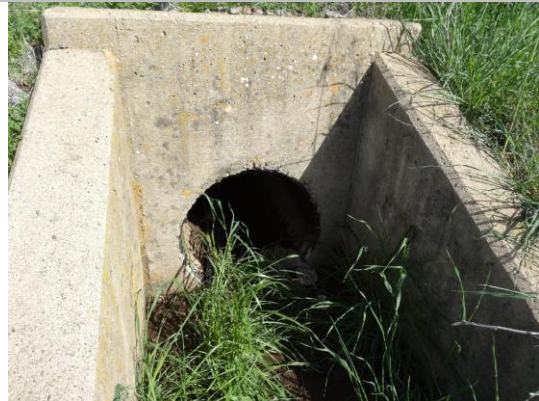
Photo 3 of 3 : UCIP_SP_2017_32124_58627.jpg

LS view: inside view of CMP on levee slope. Needs cleaning and clearing.

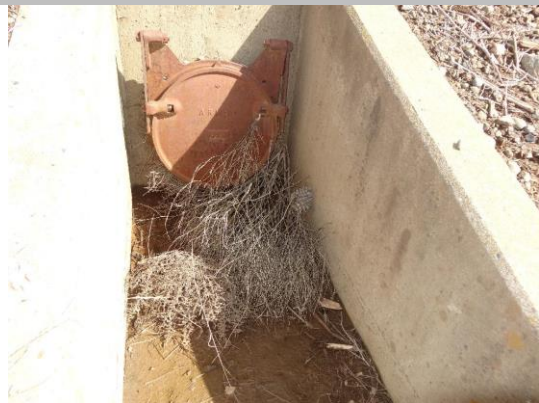
Photo 1 of 3 : UCIP_SP_2017_31901_58194.jpg

WS view: U type concrete headwall, flapgate, and CMP on levee slope. Needs cleaning and clearing.

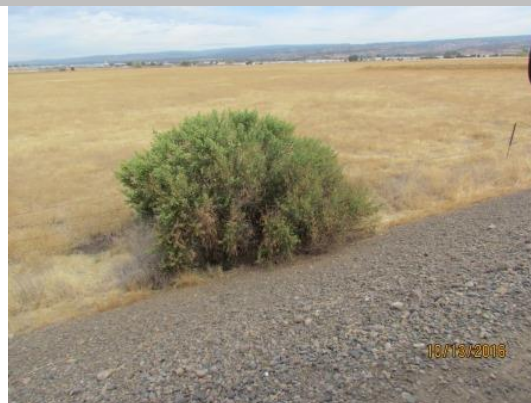
Photo 1 of 1 : SP_2017_NA0003_67_14_20170315_00003.jpg

View of a bush along the landside toe.

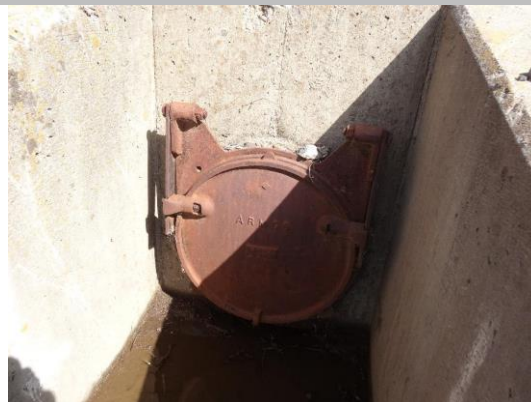
Photo 1 of 3 : UCIP_SP_2017_31856_58053.jpg

WS view: U type concrete headwall, pipe, and flapgate on levee slope.
Soil/mud on outlet box.

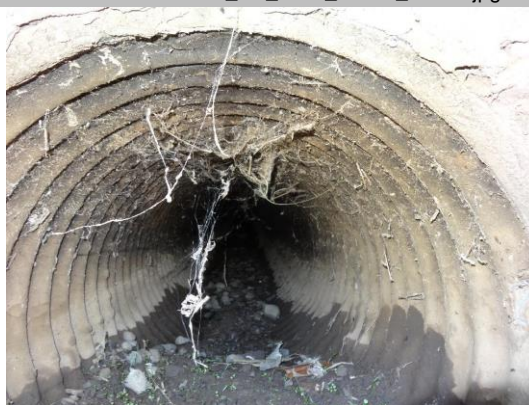
Photo 3 of 3 : UCIP_SP_2017_31856_58051.jpg

LS view: inside view of CMP on levee slope. Needs cleaning and clearing.

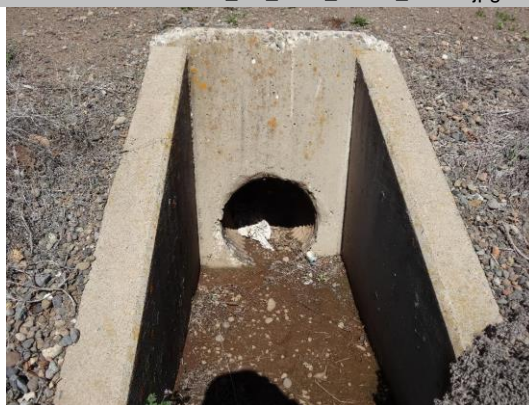
Photo 3 of 3 : UCIP_SP_2017_32026_58518.jpg

LS view: U type concrete headwall and CMP on levee slope. Mud and pebbles on inlet box.

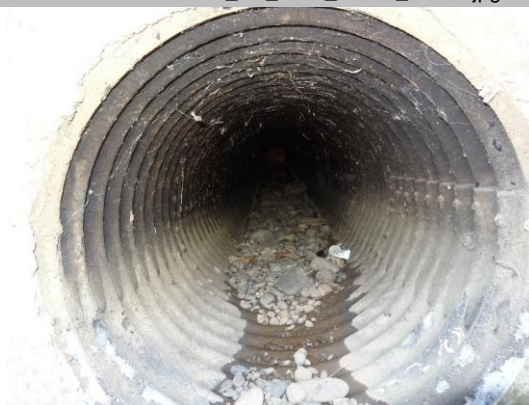
Photo 3 of 3 : UCIP_SP_2017_32023_58503.jpg

LS view: inside view of the CM pipe. Needs cleaning and clearing the pipe.

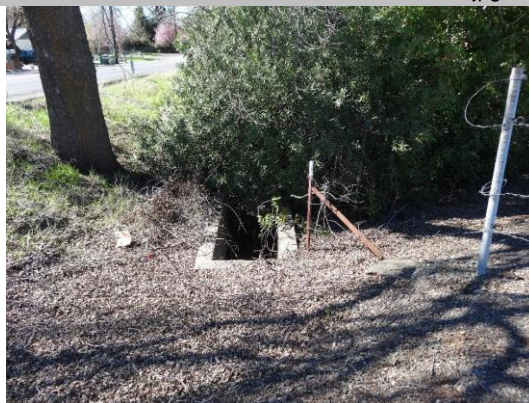
Photo 1 of 3 : UCIP_SP_2017_32144_58644.jpg

LS view: U type concrete headwall of CMP culvert on levee slope. Vegetation debris and mud on inlet box.

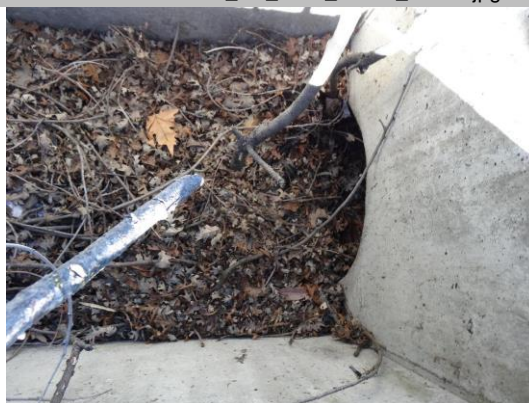
Photo 2 of 3 : UCIP_SP_2017_32144_58643.jpg

LS view: close view of vegetation debris and mud on inlet box.

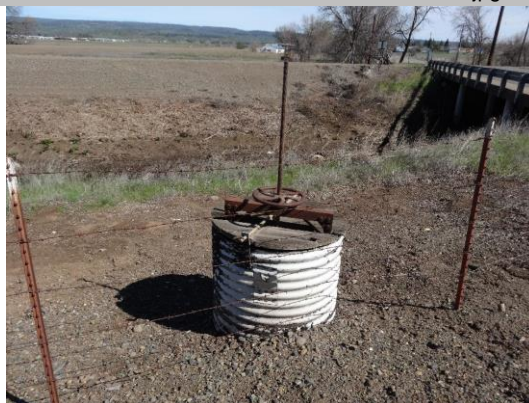
Photo 3 of 3 : UCIP_SP_2017_32144_58642.jpg

WS view: slide gate in CMP riser on waterside. No access to CMP riser.

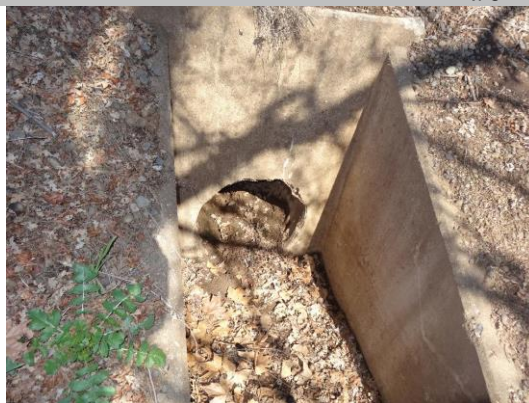
Photo 2 of 3 : UCIP_SP_2017_31963_58383.jpg

LS view: U type concrete headwall and CMP on levee slope. Vegetation debris and mud on inlet box.

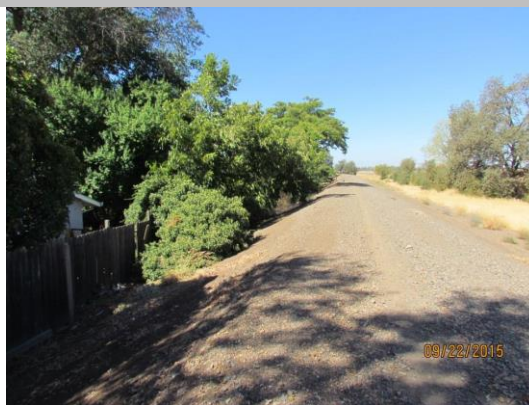
Photo 1 of 1 : SP_2017_NA0003_68_17_20170315_00004.jpg

View of the trees overhanging the levee slope.

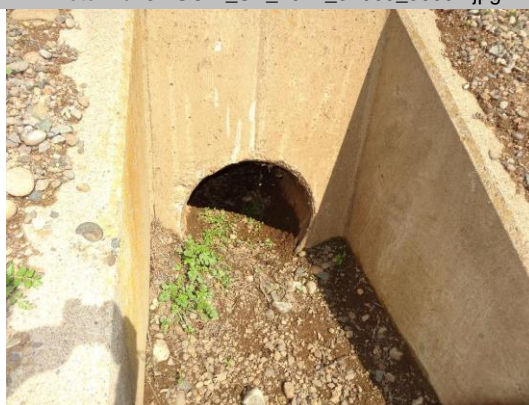
Photo 2 of 3 : UCIP_SP_2017_31965_58394.jpg

LS view: U type concrete headwall and CMP on levee slope. Vegetation debris and mud in inlet box.

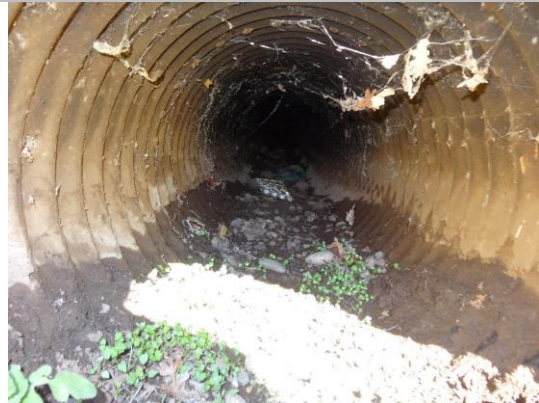
Photo 3 of 3 : UCIP_SP_2017_31965_58393.jpg

LS view: inside view of CMP on levee slope. Needs cleaning and clearing.

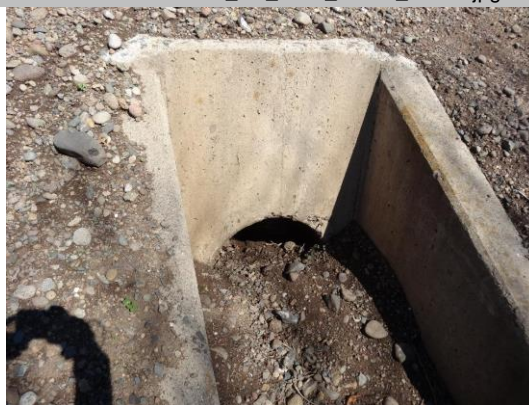
Photo 3 of 3 : UCIP_SP_2017_31966_58399.jpg

LS view: U type concrete headwall and CMP on levee slope. Vegetation debris and mud in pipe and inlet box.

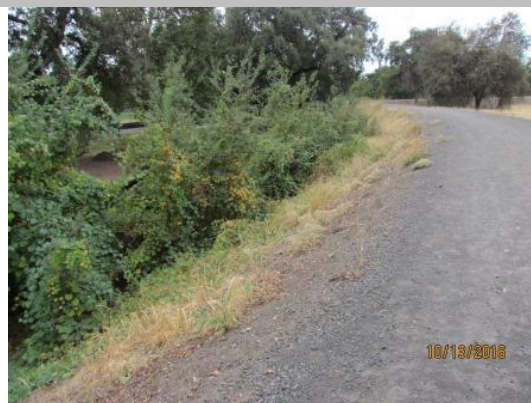
Photo 2 of 2 : SP_2017_NA0003_69_3_20170315_00001.jpg

View of the vegetation along the landside slope and toe.

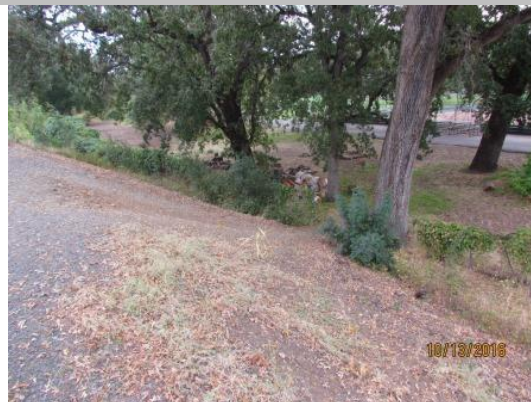
Photo 1 of 1 : SP_2017_NA0003_69_11_20170315_00005.jpg

View of the damaged slope by foot traffic.

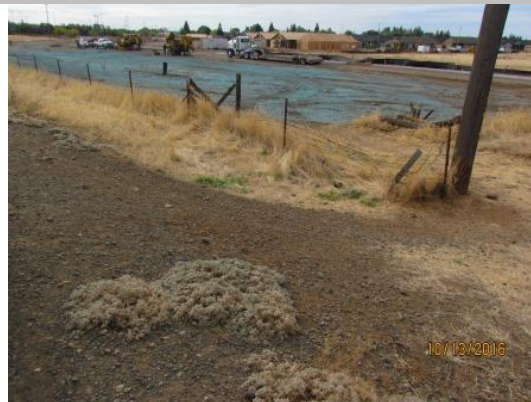
Photo 1 of 1 : SP_2017_NA0003_69_13_20170315_00007.jpg

View of the damaged slope by foot traffic.
